Smoke and Dye Testing Summary

High Level Sewershed

Run Summary

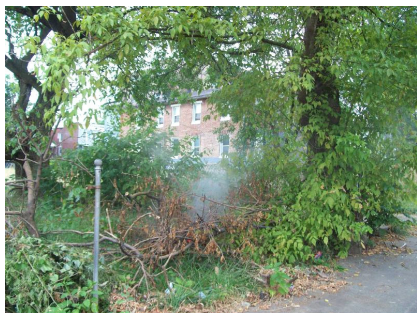
Picture \S1028-174-OB01-P01.jpg

Comments Smoke from below-grade cleanout in back yard. 2852 Lanvale St.

Comments Back of house, 2852 Lanvale St.

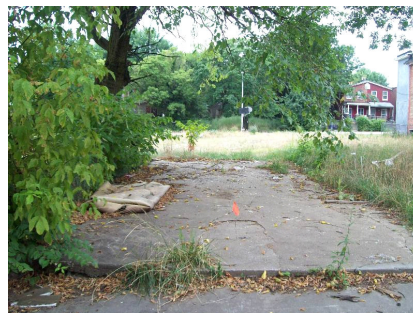
Picture \S1028-174-OB02-P01.jpg

Comments Smoke from cleanout in concrete pad of vacant lot. 2854 Lanvale St.

Comments Back of lot, 2854 Lanvale St.
